Accelerated Corrosion Analysis of E-Coated Steel Box Panels to Determine Reapplication Intervals for Carwell Inhibitor

ARL-RP-34

A reprint from the Proceedings of 1999 Tri-Service Conference on Corrosion,
Myrtle Beach, SC, 15-19 November 1999.

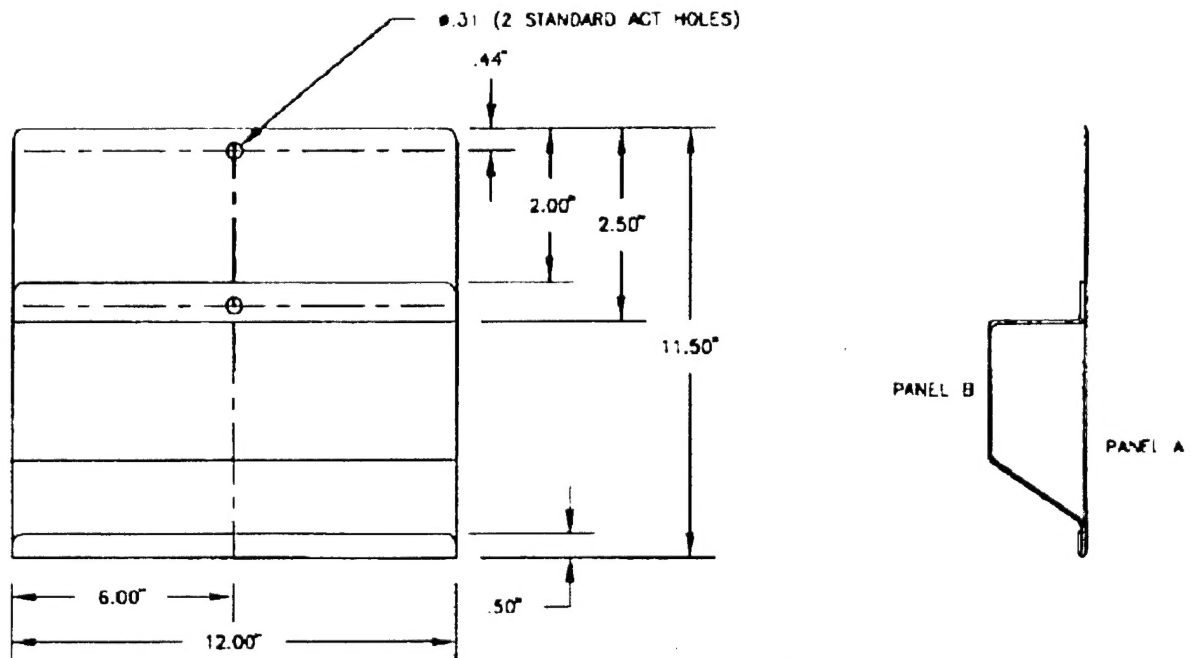
Figure 1: Box Panel Specimen Specifications

Box Interior Cavity Assemblies Are Constructed From Two 9x9" Panels. The Top Panel (Panel B.) Is Joined at a 90 Degree Angle With 1/2" Seam 2.5" From the Top of Panel A. The Two Panels Are Joined With a Hemflange Seam at the Bottom. Ends May Be Opened or Closed. (*ACT Laboratories*)

E-coated steel panels¹ with CARC² topcoat were received from Ocean City Research (OCR) for testing (Figure 1). Of the 24 received, 16 were treated with CARWELL rust inhibitor by ATC with 8 panels each designated for mounting on the test vehicle and for the GM 9540P test chamber. The remaining 8 panels were left untreated and were also exposed to GM 9540P in the test chamber. In order to facilitate periodic viewing of the lap joint crevice, the spot welds located at the top portion of the box panel were removed via drilling allowing direct line of sight observation.

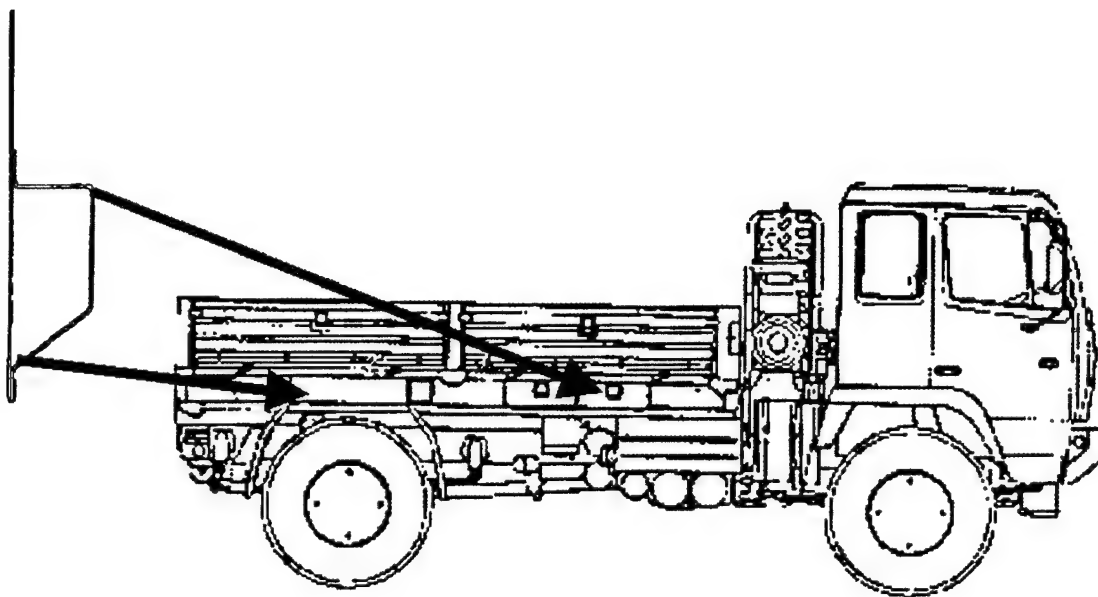
Figure 2: Test Vehicle Mounting Locations – 4 Specimens per Side

For the test track exposure, the introduction of mud and other debris was prevented using end caps fabricated of styrofoam, secured to the box panels using a combination of nylon tie fasteners and rubber bands. Nylon ties were also used to secure the box panel assemblies to the framing members located under the cargo bed of the truck (Figures 2, 3). The exposure intervals for the test vehicle were defined in 15 day phases with each phase being equivalent to one year exposure in a representative U.S. Army tactical environment.³ The box panels were inspected at the end of each phase. Failure of the box panels was defined as the appearance of blisters on the interior of the lap joint. The application rate was adjusted during testing from every phase to every third phase on the vehicle based upon the performance in the lap joint interior of the box panels and numerical agreement with other flags.
